DEPARTMENT OF TRANSPORTATION

Quality Assurance and Source Inspection

Contract #: 04-0120F4Cty: SF/ALA Rte: 80 PM: 13.2/13.9File #: 69.28**WELDING INSPECTION REPORT****Resident Engineer:** Pursell, Gary**Address:** 333 Burma Road**City:** Oakland, CA 94607**Report No:** WIR-003606**Date Inspected:** 26-Jul-2008**Project Name:** SAS Superstructure**OSM Arrival Time:** 1430**Prime Contractor:** American Bridge/Fluor Enterprises, a JV**OSM Departure Time:** 2230**Contractor:** Zhenhua Port Machinery Company, Ltd (ZPMC), Changxing Island **Location:** Shanghai, China**CWI Name:** Chen Xi and Li Yan Hua**CWI Present:** Yes No**Inspected CWI report:** Yes No N/A**Rod Oven in Use:** Yes No N/A**Electrode to specification:** Yes No N/A**Weld Procedures Followed:** Yes No N/A**Qualified Welders:** Yes No N/A**Verified Joint Fit-up:** Yes No N/A**Approved Drawings:** Yes No N/A**Approved WPS:** Yes No N/A**Delayed / Cancelled:** Yes No N/A**Bridge No:** 34-0006**Component:** deck panels / skin plates and stiffeners**Summary of Items Observed:****Tower Shop – Bay 1**

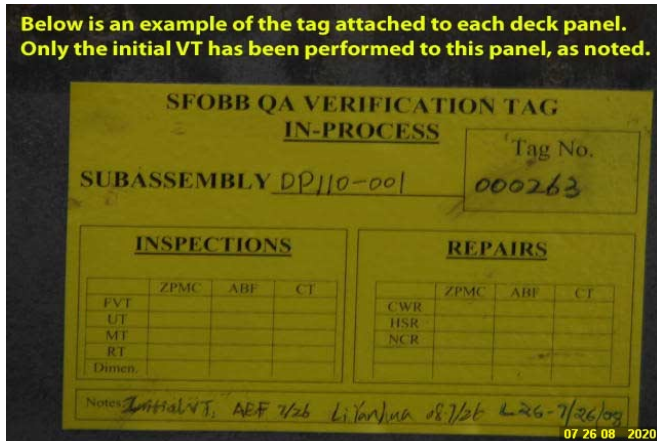
Below is an example of the tag attached to each deck panel.
Only the initial VT has been performed to this panel, as noted.
